Gavin Central Elementary School

Observations related to Annual Roof Truss Inspection by Legat Architects

Date: 12/22/2008

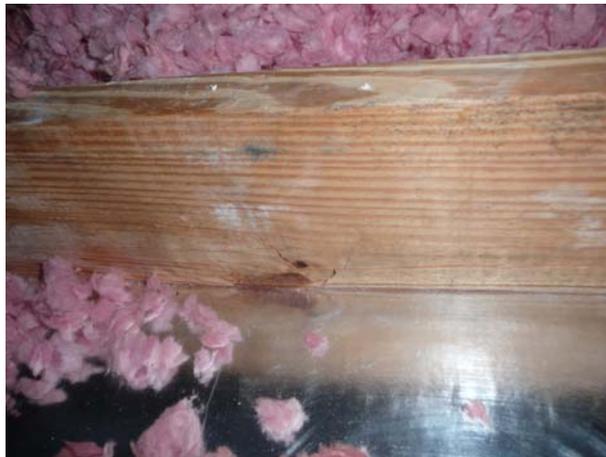
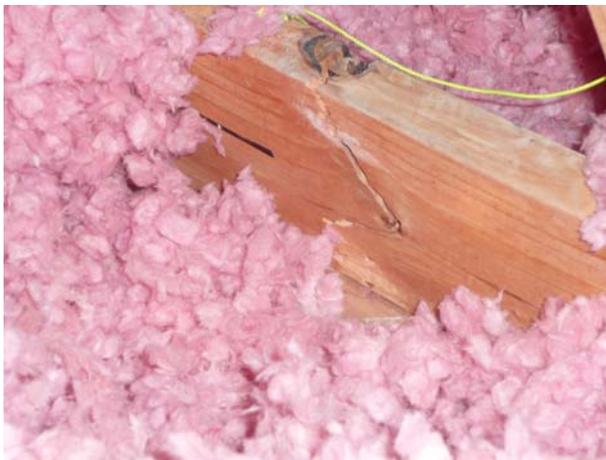
During the course of the Truss Inspection performed by Legat Architects, 2 breaks; one full and one partial were found. The suggested fix for the trusses will be presented by Legat Architects under separate cover.

Damage that was discovered on the two truss bottom chords is similar to the type of damage that was found during the original observation and repair effort. The repair proposed for the two recently discovered fractures is consistent with that of the original repair protocol.

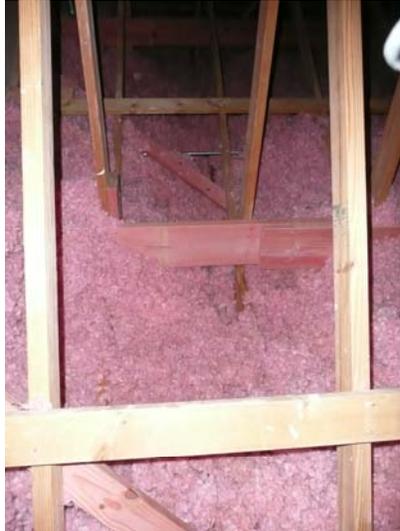
During the normal course of review of the bottom chords of the trusses, it is necessary to displace the blown-in insulation between the trusses in order to observe the bottom chords. The displacement of insulation creates various mounds of insulation and has the appearance of hills and valleys in the insulated attic space being observed. ***In order to better maintain an evenly insulated attic, it recommended that the insulation be respread in an even manner and to a level consistency.***

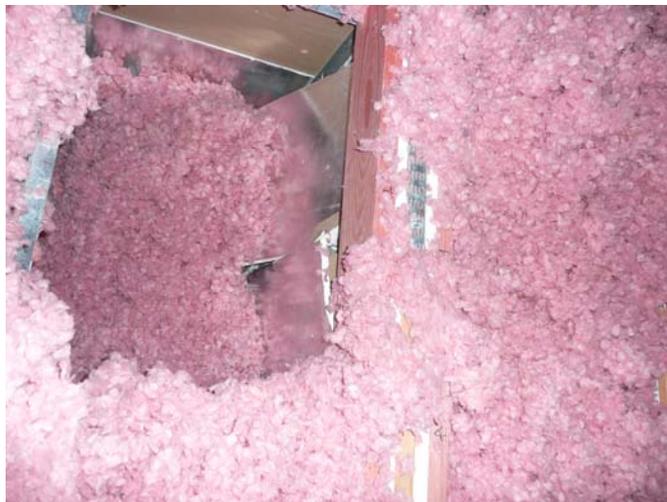
Secondly, there were about a half-dozen areas throughout Modules A & C (Classroom Wings North and South, respectively) where there are sections of drywall that have fallen from the bottom chord of the trusses and are now resting on the ceiling grid below. These areas for the most part are within 3' – 4' from the catwalk that is centered on the hallway below in each wing. If left in the current condition and especially with the current weather conditions, there is a possibility that the sprinkler system in the corridor will be exposed to severe cold temperatures and runs the risk of freezing which could cause a pipe or sprinkler head to burst. ***In order to maintain an evenly insulated attic and reduce exposure of the sprinkler piping to extreme temperatures, it recommended that the broken sections of drywall be removed and replaced as well as additional insulation installed to replace the insulation that has fallen out of the attic space into the space above the corridor ceiling.***
