Gavin Central Elementary School

Observations related to Annual Roof Truss Inspection by Legat Architects

Date: March 27, 2013

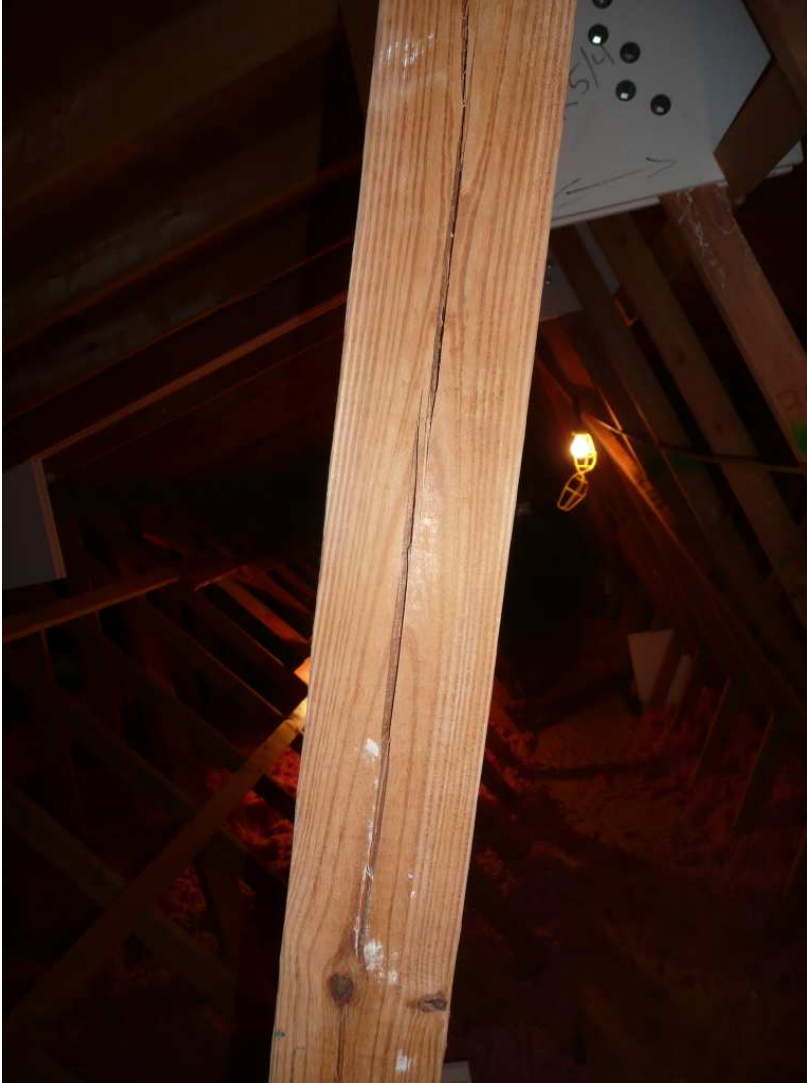
- **Module A: Truss #26 – Full Diagonal Chord Split; Immediately adjacent to Catwalk. This diagonal was identified by DLA Architects and brought to the attention of Legat Architects and WJE for review. WJE determined split has gone more than 50% of the way through the member section.**

- ***Module A: Truss #26 – Full Diagonal Chord Split; Immediately adjacent to Catwalk. This diagonal was identified by DLA Architects and brought to the attention of Legat Architects and WJE for review. WJE determined split has gone more than 50% of the way through the member section.***

WJE has reviewed and will be developing a fix

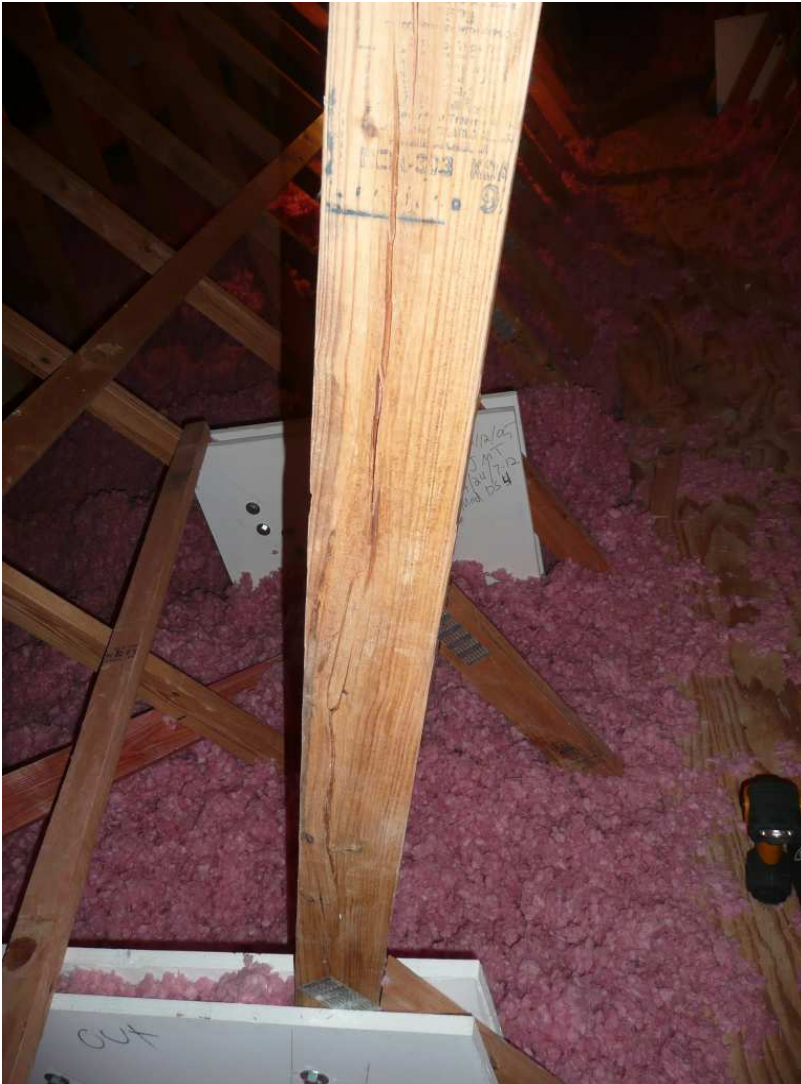
- **Module A: Truss #26 – Full Diagonal Chord Split; Immediately adjacent to Catwalk. This diagonal was identified by DLA Architects and brought to the attention of Legat Architects and WJE for review. WJE determined split has gone more than 50% of the way through the member section.**

It was noted in the field that this split diagonal member is immediately adjacent to a past truss correction at a spliced connection repair. Because of this relationship to a past break, this condition was pointed out to WJE for review and they have agreed that condition warrants a designed “Fix”.

WJE has reviewed and will be developing a fix

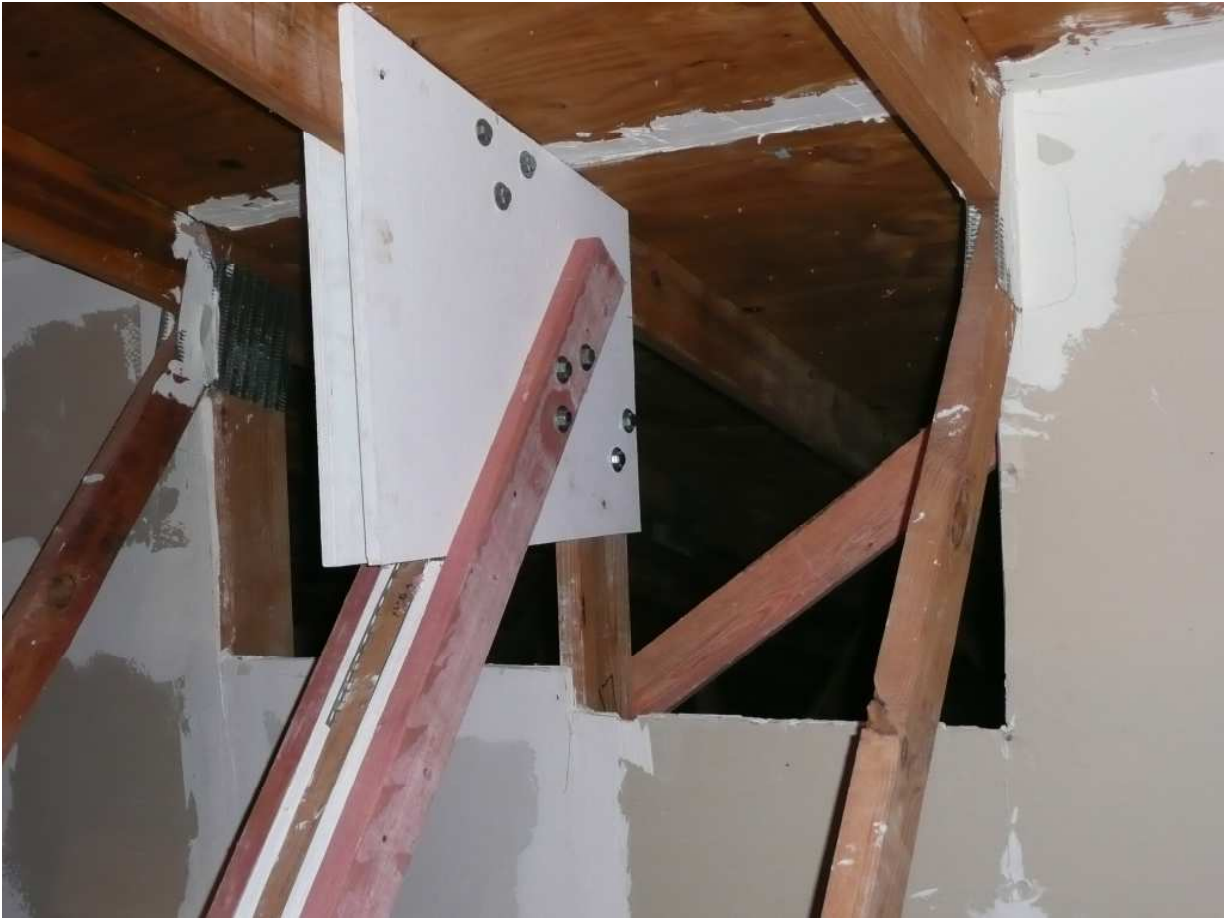
- **Module A: Between Trusses #16 & #18 – The drywall Fire Separation which is required by Code was opened up for an engineered fix at Truss #17 from last year’s inspection. The drywall was removed for the correction and never re-established. The drywall needs to be patched to re-establish the required Fire Barrier.**

- ***Module A: Between Trusses #16 & #18 – The drywall Fire Separation which is required by Code was opened up for an engineered fix at Truss #17 from last year’s inspection. The drywall was removed for the correction and never re-established. The drywall needs to be patched to re-establish the required Fire Barrier.***

Work to be corrected by Boller Construction

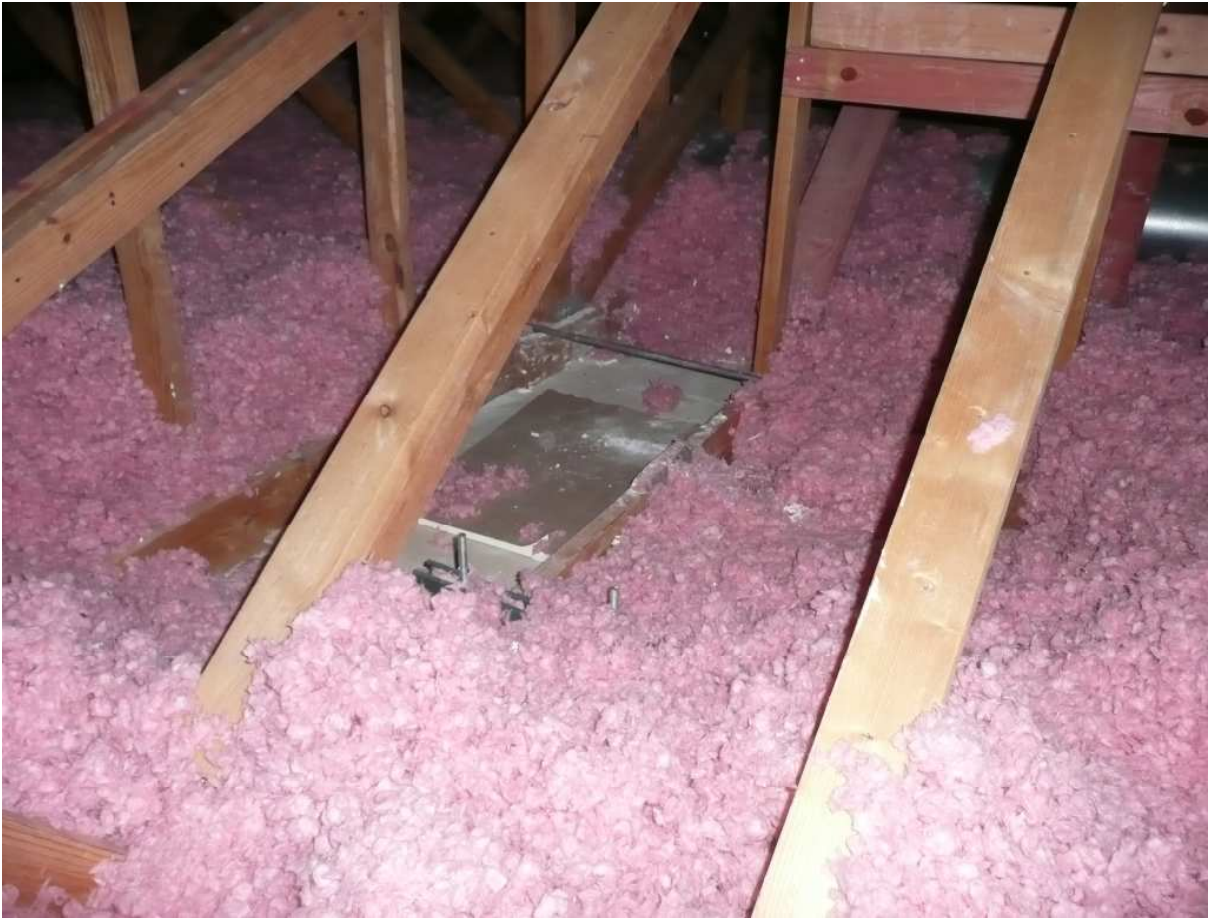
- **Module A: Between Trusses #1 & #2 – During the course of previous corrective Work, an area of drywall ceiling was opened up to supply materials for other corrective Work. The drywall ceiling was repaired but never recovered with insulation. The insulation is required to be respread.**

- ***Module A: Between Trusses #1 & #2 – During the course of previous corrective Work, an area of drywall ceiling was opened up to supply materials for other corrective Work. The drywall ceiling was repaired but never recovered with insulation. The insulation is required to be respread.***

Work to be corrected by Boller Construction

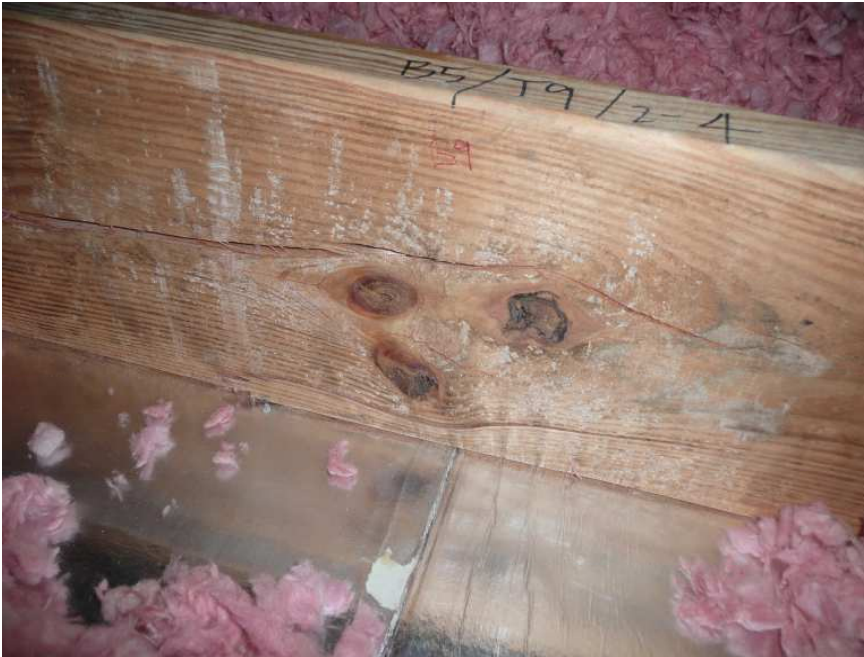
- **Module B: Truss #B5-9 – Partial Bottom Chord Fracture at Multiple knots– Horizontal Split originating at a past Plate correction made in the past**

It was noted in the field that for the most part, a break of this type has not been documented in the past in this area of the building.

WJE has reviewed and will be developing a fix

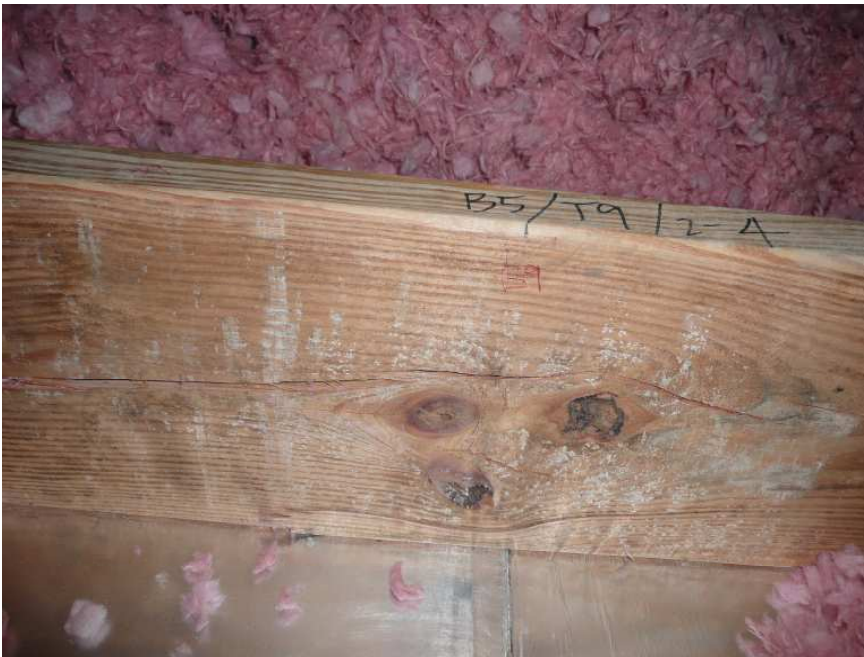
- **Module B: Truss #B5-9 – Partial Bottom Chord Fracture at Multiple knots– Horizontal Split originating at a past Plate correction made in the past**

WJE has reviewed and will be developing a fix

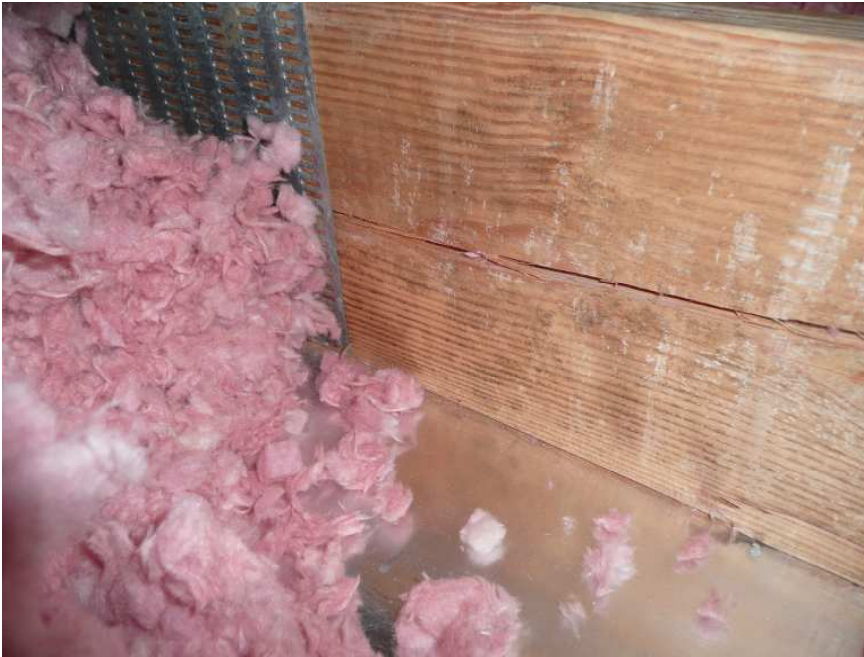
- **Module B: Truss #B5-9 – Partial Bottom Chord Fracture at Multiple knots– Horizontal Split originating at a past Plate correction made in the past**

WJE has reviewed and will be developing a fix

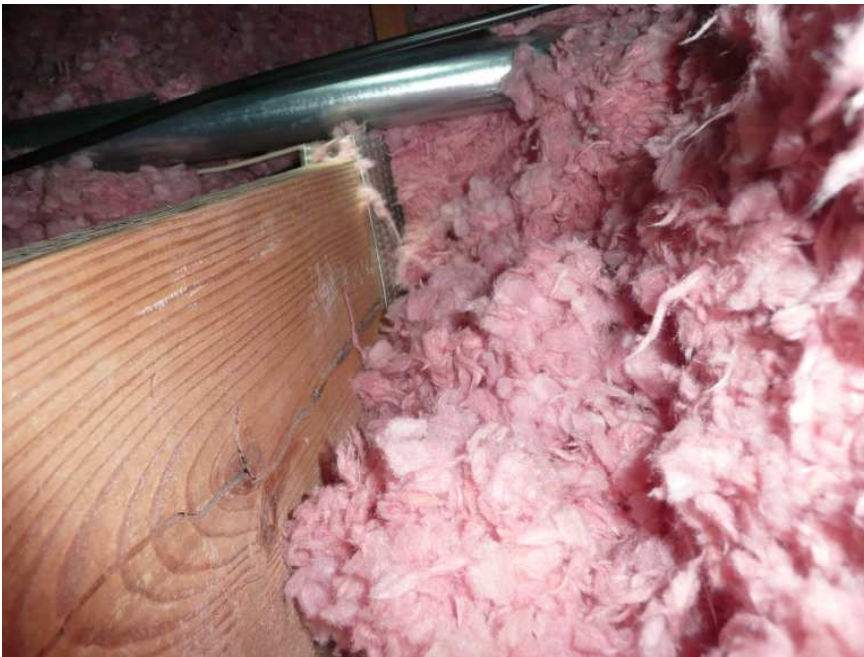
- **Module B: Truss #B5-9 – Partial Bottom Chord Fracture at Multiple knots– Horizontal Split originating at a past Plate correction made in the past**

WJE has reviewed and will be developing a fix

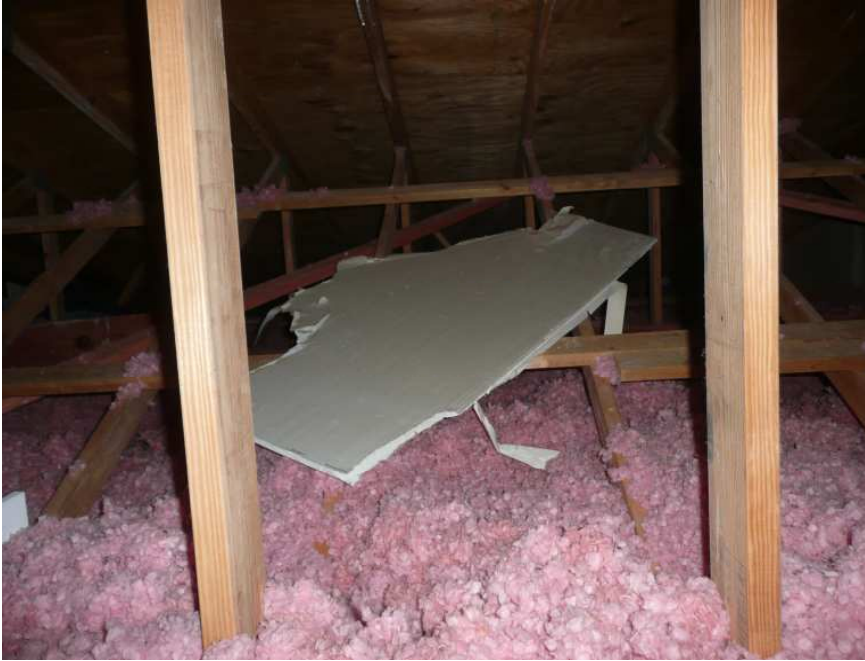
- **Module C: Drywall Debris**
There are sections of drywall that have been left in the attic space from earlier repair jobs. Extra material needs to be removed from the attic space.

- **Module C: Drywall Debris**
There are sections of drywall debris that have been left in the attic space from earlier repair jobs. Extra material needs to be removed from the attic space.

It is recommended that all unused (extra) materials present in the attic space be removed upon completion of all truss fixes. It is a hazard to have extra material lying around while trying to maneuver through the trusses. Most material is of the size that it could be easily removed from the attic to make future observations more readily accessible.
