# Gavin Central School

Ingleside, Illinois

## 2006 GAVIN INSPECTION

# 2007 GAVIN INSPECTION

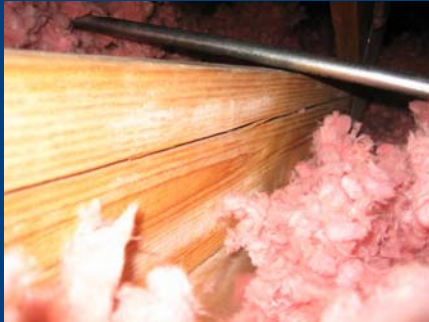
## North Module – Truss 77: Bottom Chord Split

Bottom Chord Split

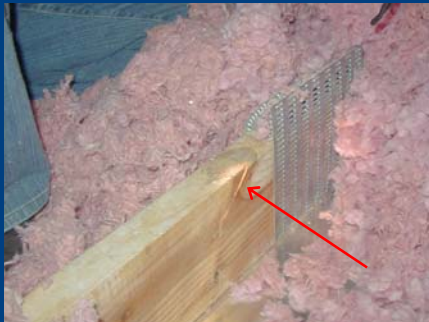
## North Module – Truss 26

Bottom Chord Partial Fracture

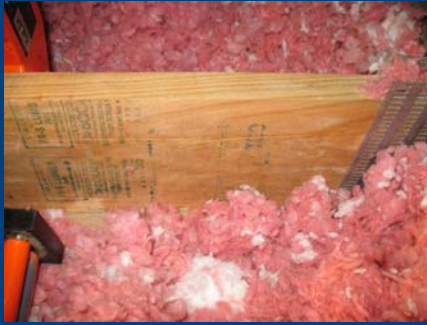
## Center Module – Truss 10

Bottom Chord Check

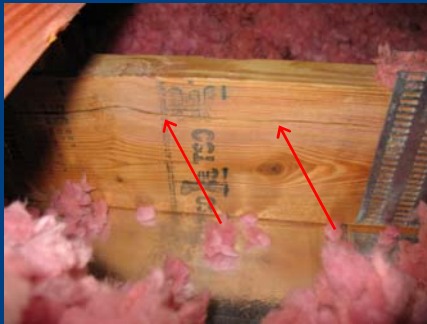
## South Module – Truss 24

Bottom Chord Split

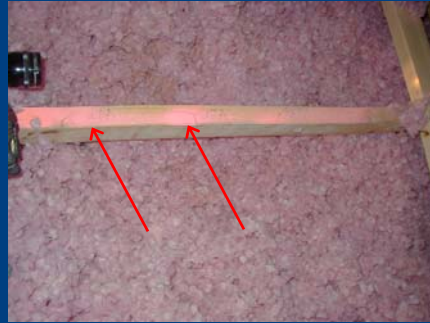
South Module – Truss 27A

To Be Investigated
