May 14, 2012

Gavin School District 37
Gavin Central School
Roof Truss Inspection

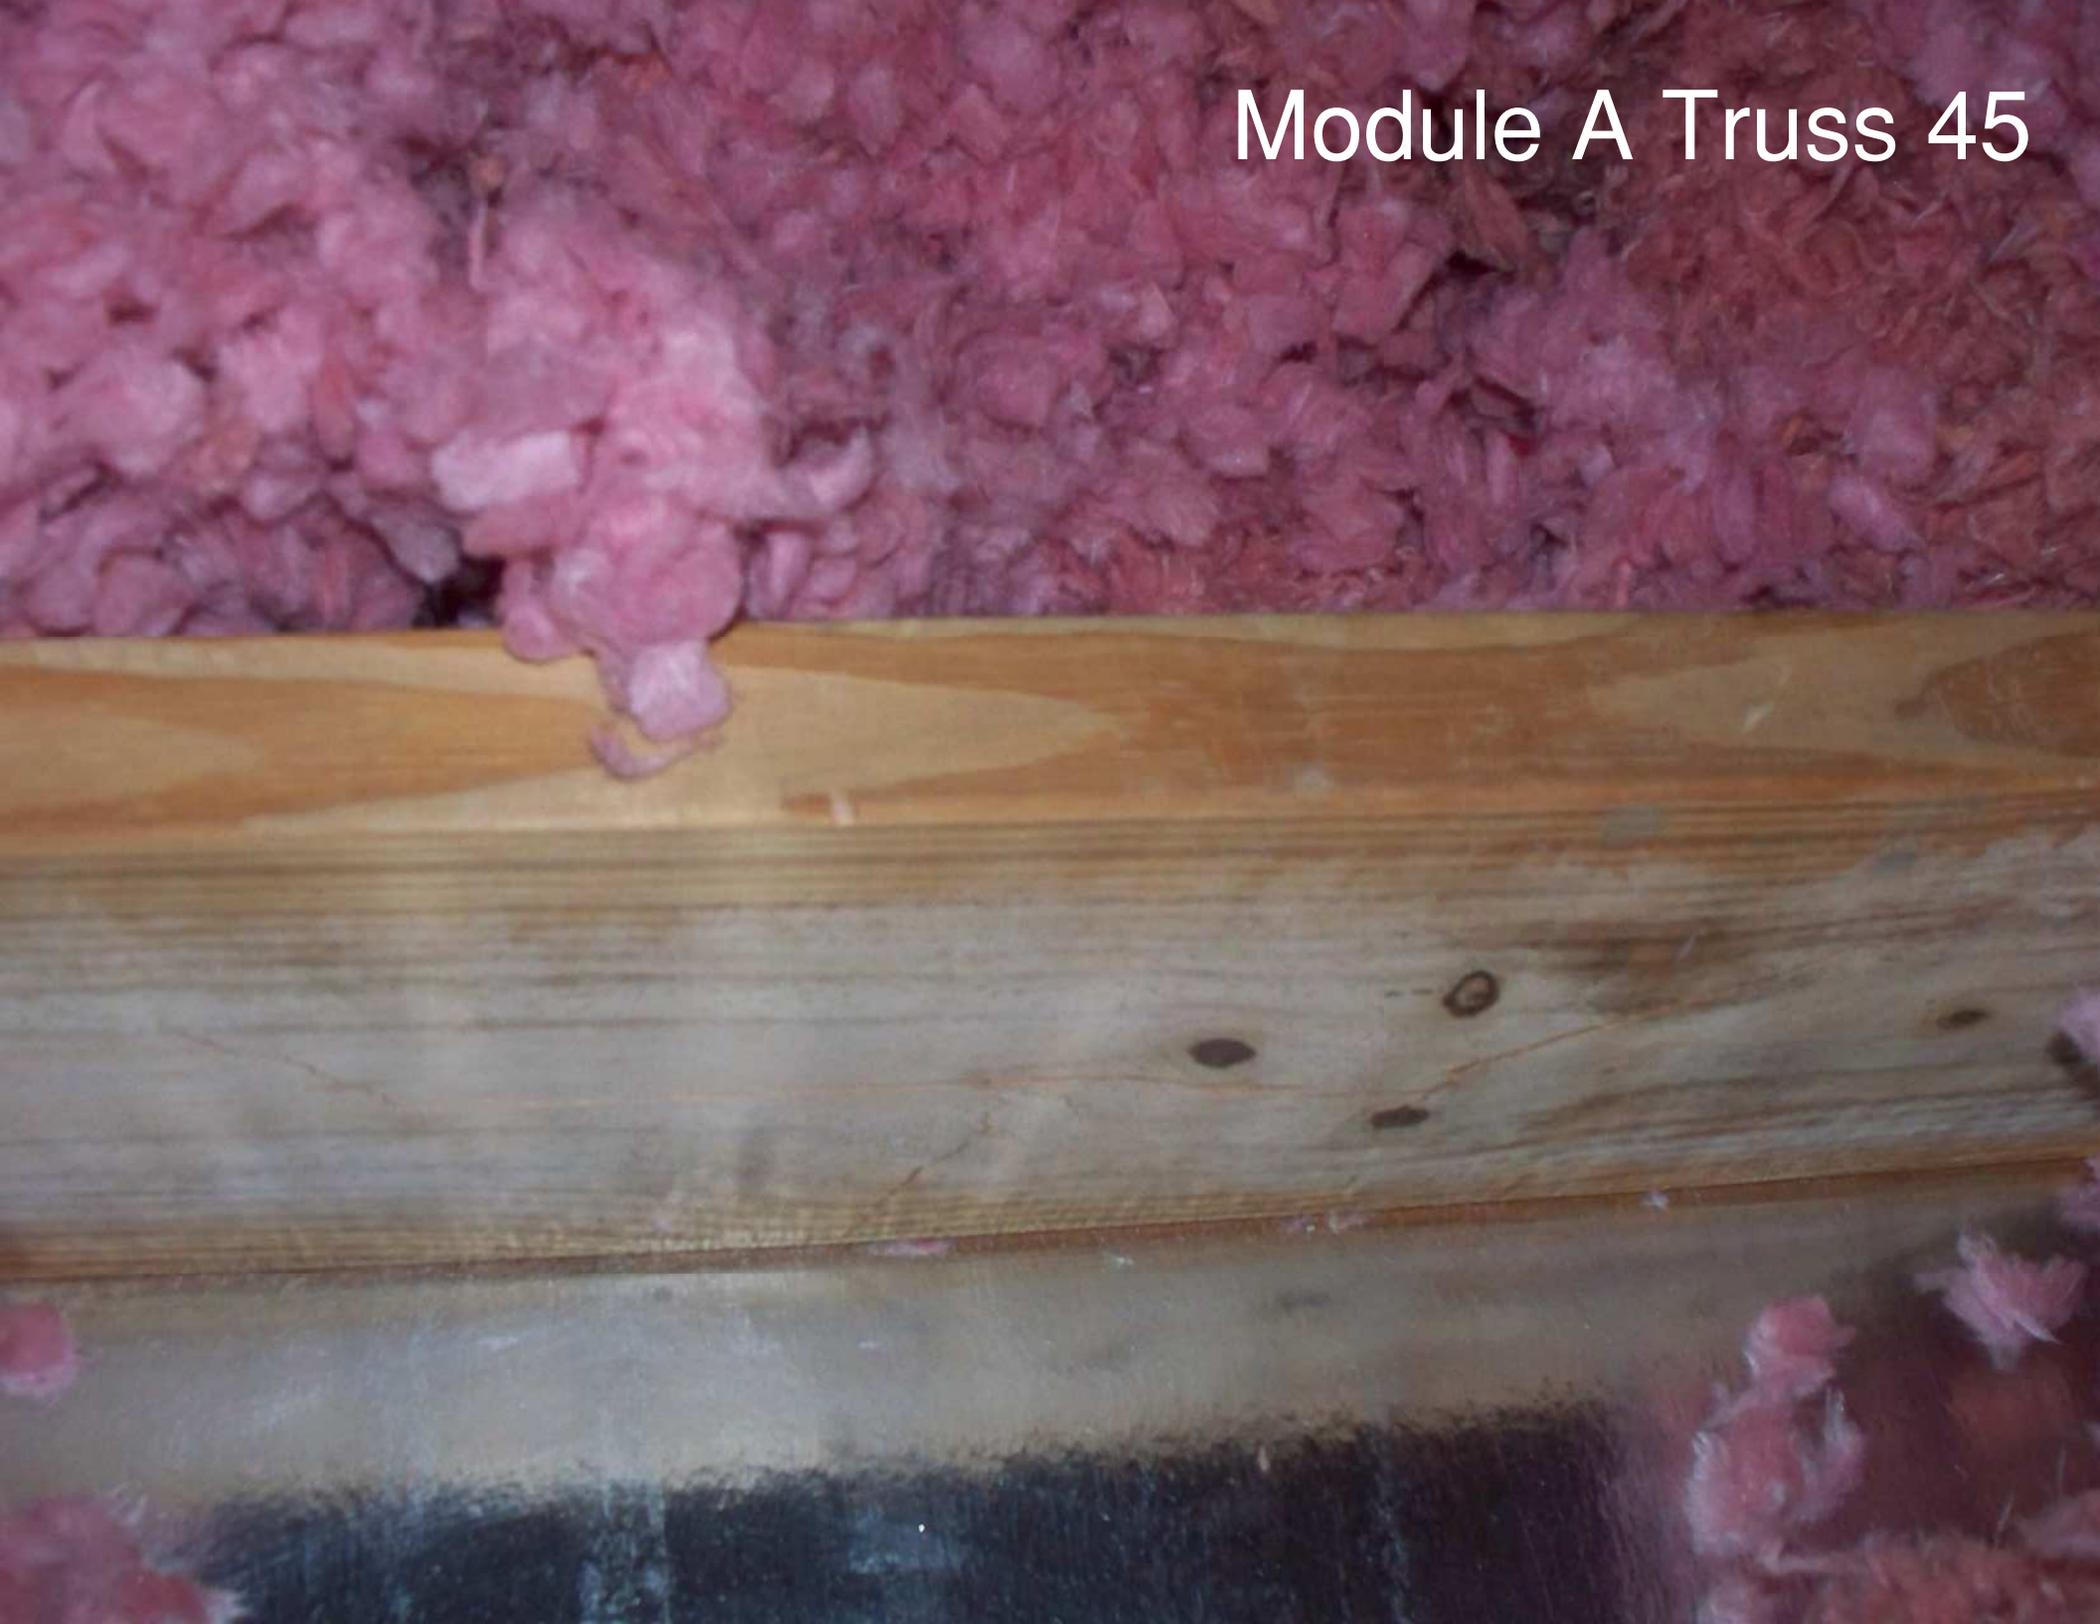
Module A Truss 45

In Module A, Trusses 45 and 47 were found to have a partial bottom chord fractures. Truss 46 was found to have a full bottom chord fracture at a naturally occurring knot in the lumber. In Module B, Truss B6-19 was found to have a partial bottom chord fracture. We will schedule a meeting with Jon Sfura from WJE and Ralph Schmidt representing the Regional Superintendent of Schools to review the conditions of concern. WJE will then prepare repair details for each of the conditions.
