Gavin Central Elementary School

Observations related to Annual Roof Truss Inspection by Legat Architects

Date: March 27, 2012

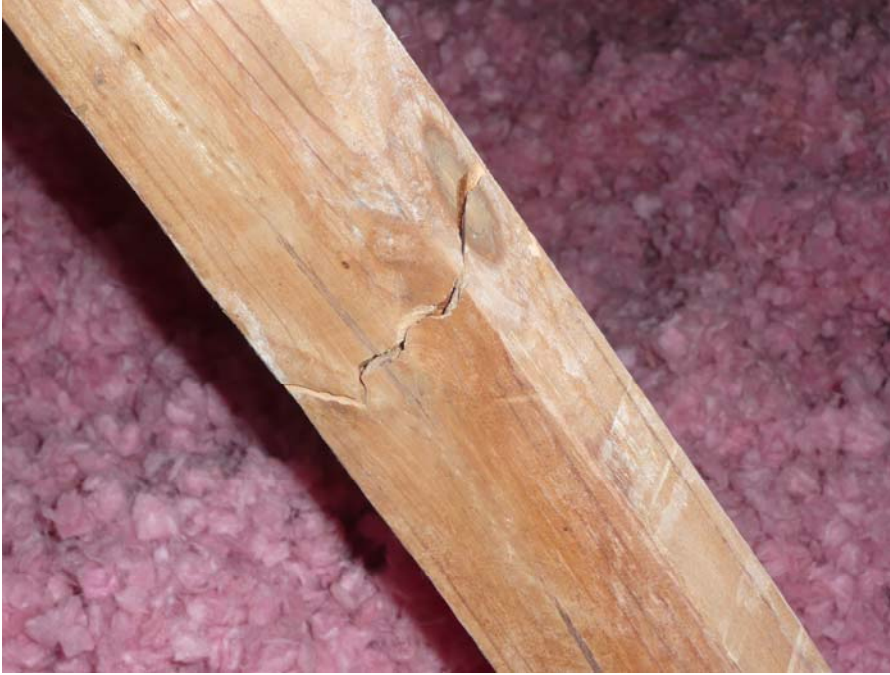
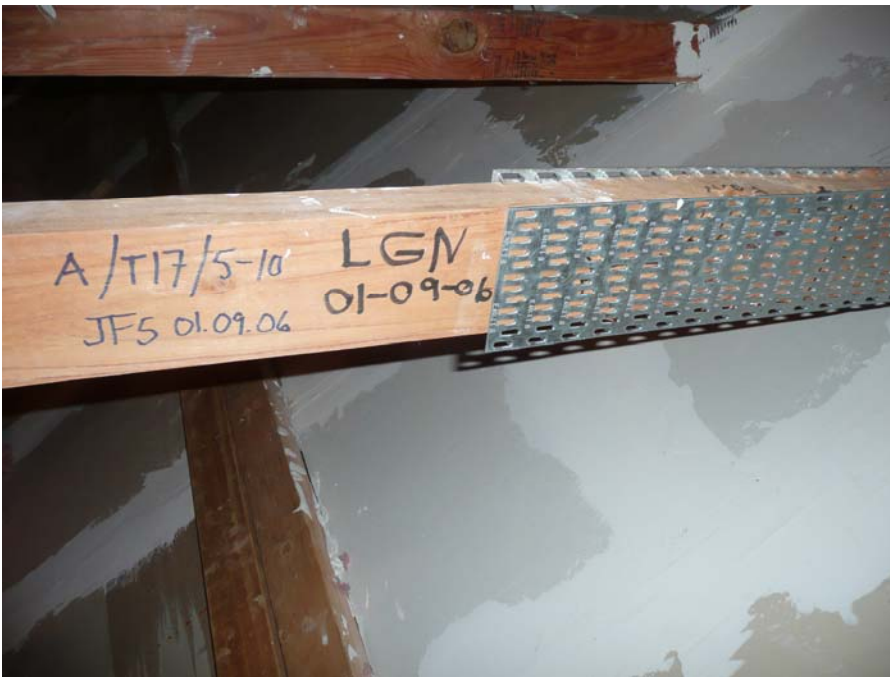
- **Module A: Truss #17 – Full Diagonal Chord Fracture; North side of Catwalk**
WJE has reviewed and will be developing a fix

It was noted in the field that a break of this type has not been documented in the past and has not been the typical type of break seen in other observations of the trusses.

It was also noted in the field that this truss had been marked with tag indicating that this truss has been observed and marked for repair on 1/9/2006.

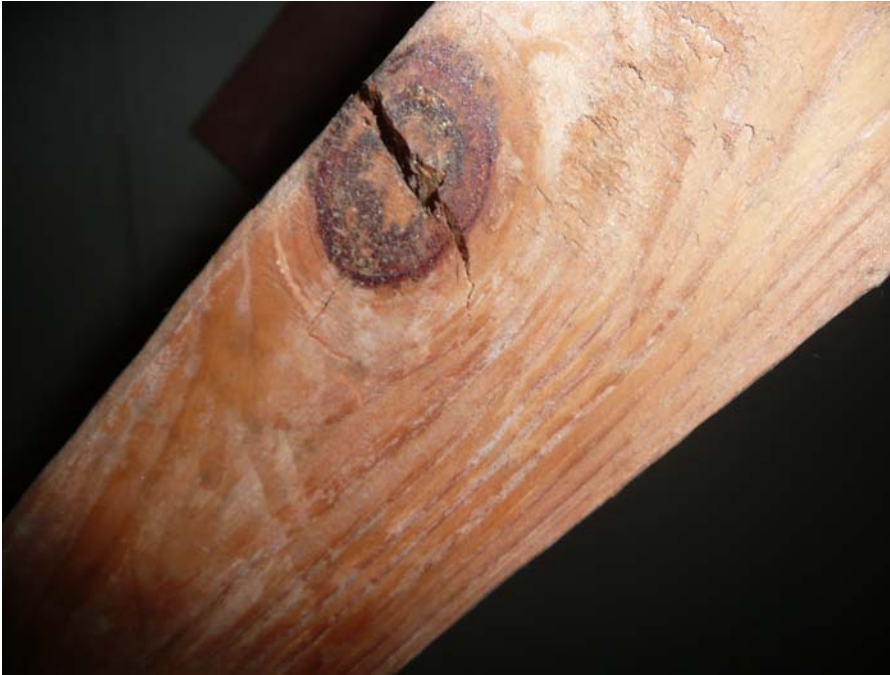
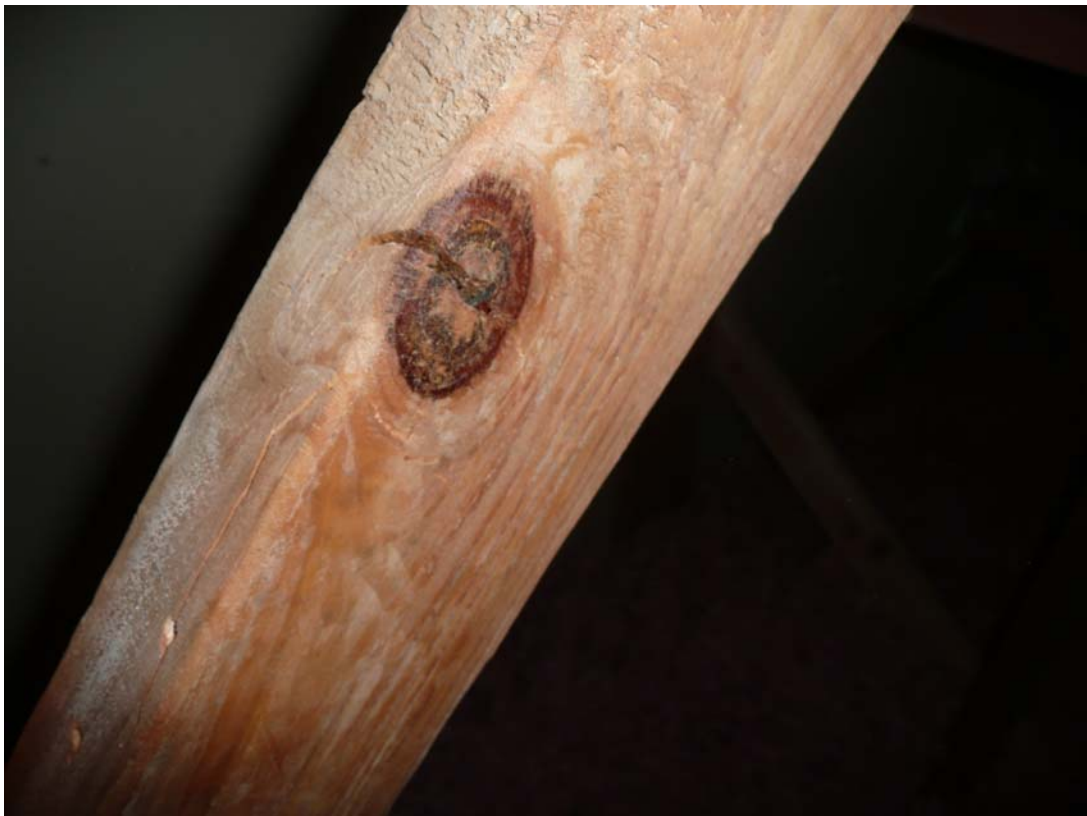
- ***Module A: Truss #83 – Partial Diagonal Chord Fracture- through knot; North side of Catwalk***

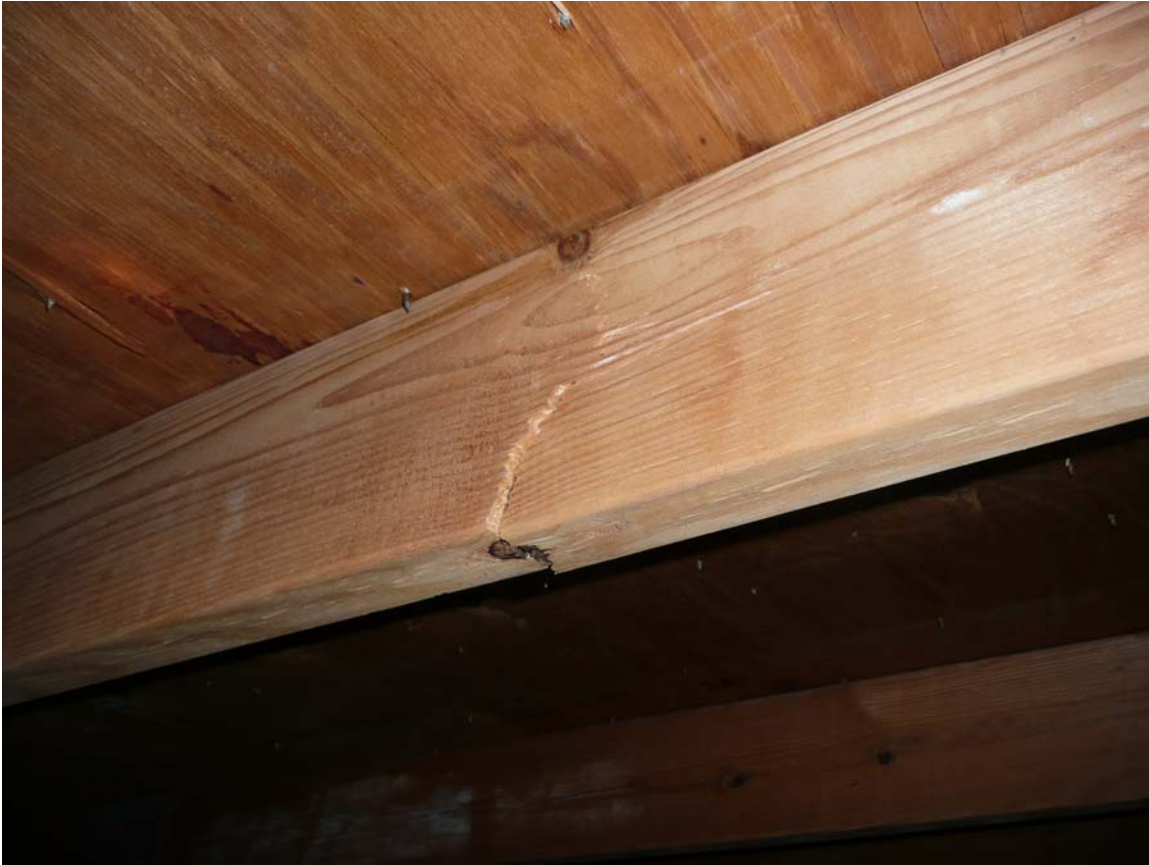
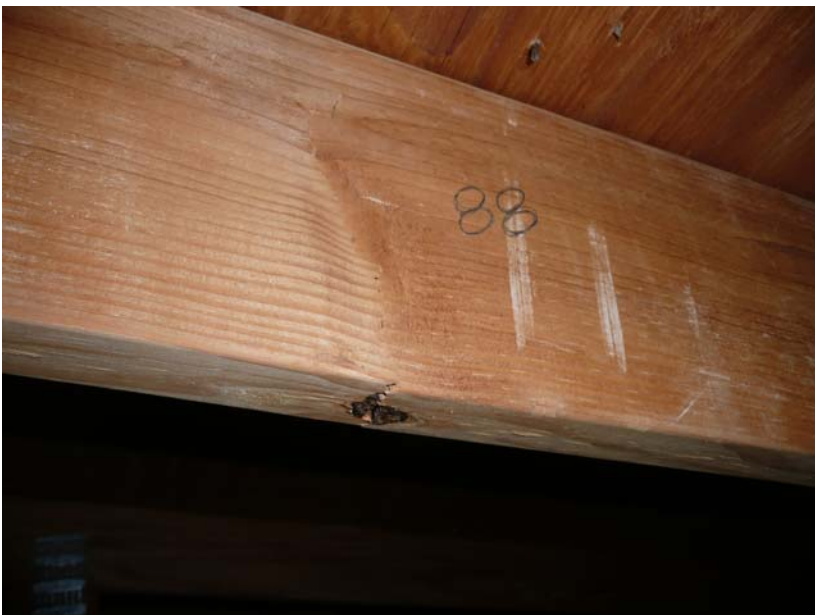
- **Module A: Truss #88 – Full Top Chord Fracture; South side of Catwalk**
WJE has reviewed and will be developing a fix

It was noted in the field that a break of this type has not been documented in the past and has not been the typical type of break seen in other observations of the trusses.

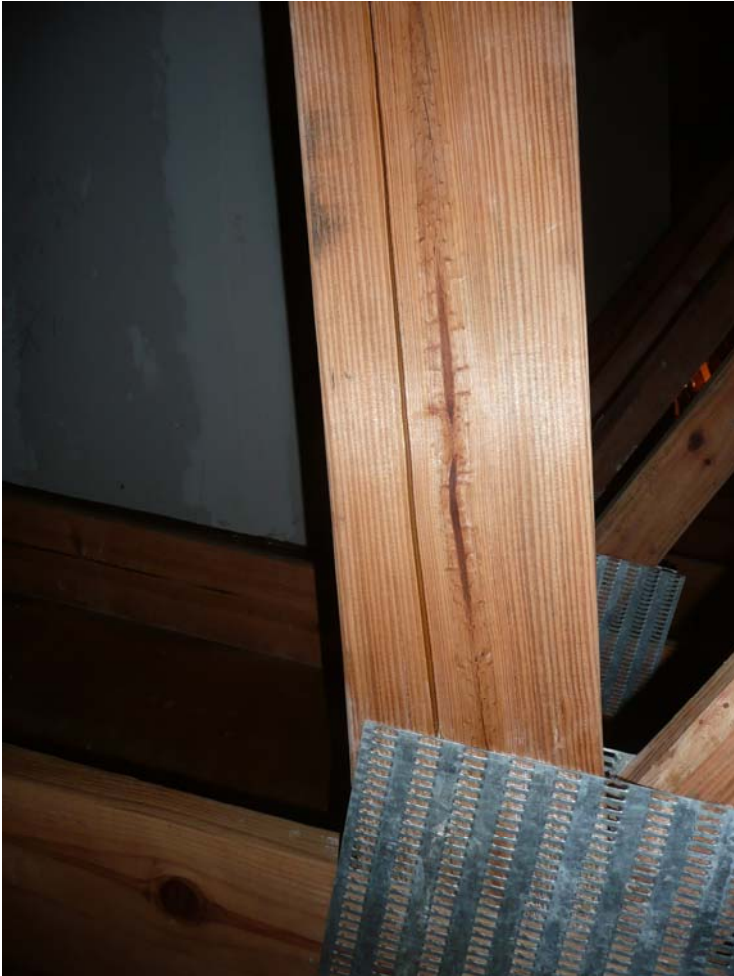
- **Module A: Trusses #32 & #33 – Full Vertical Split from Spike Plate to Spike Plate
Approximately 8'-0" long; South side of Catwalk
WJE has reviewed and will be developing a fix (Add plate both sides)**

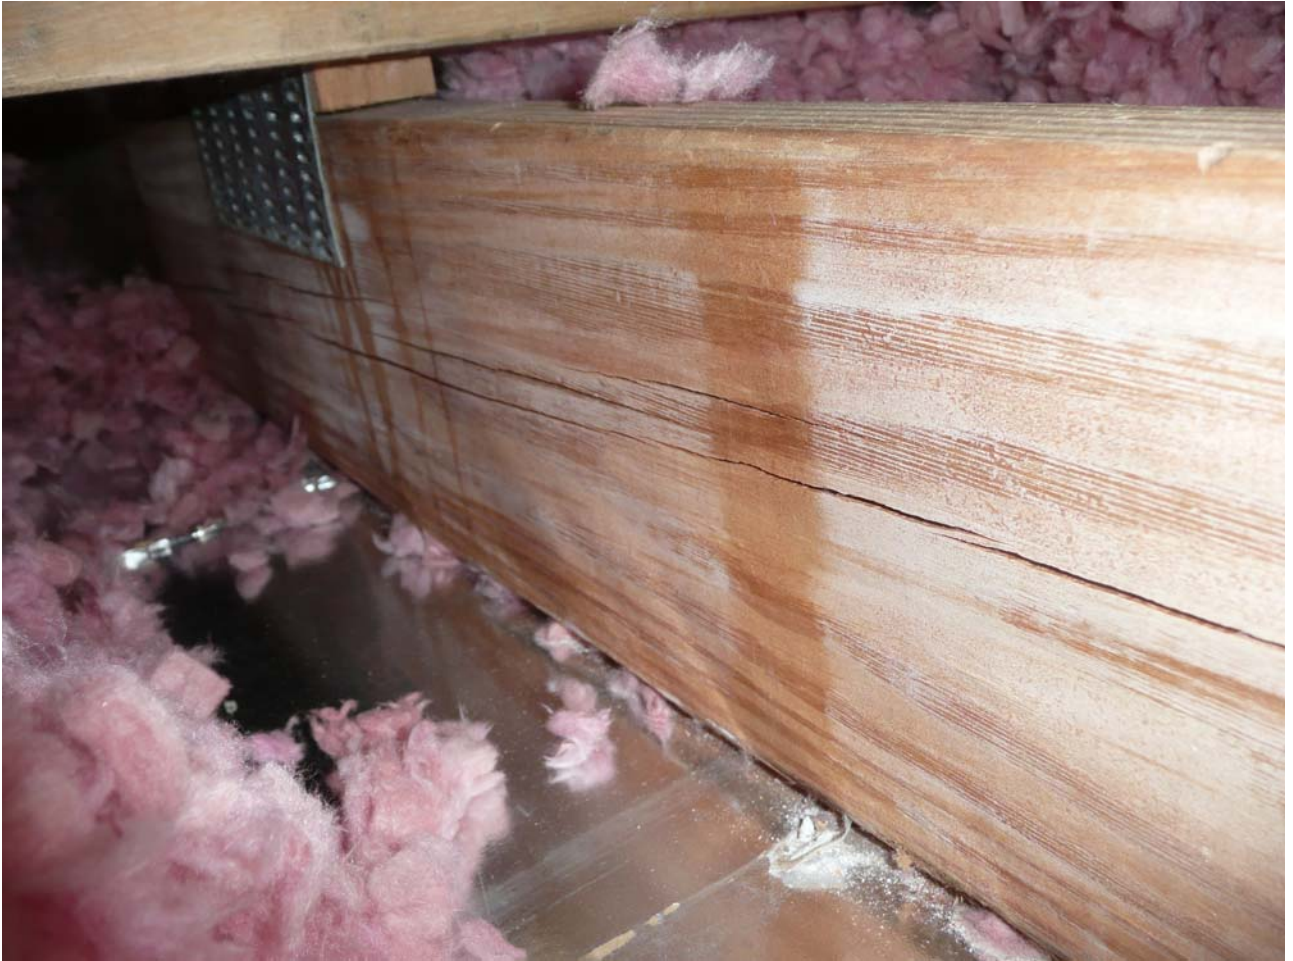
- **Module A: Trusses #58 & #59 – Horizontal Checks Approximately 6-0” long; North side of Catwalk Appears to be Juvenile Wood**
WJE has reviewed and will be developing a fix (Add plate both sides)

It was noted in the field that the development of the check is within 6” of hanger for piping or mechanical equipment below truss.

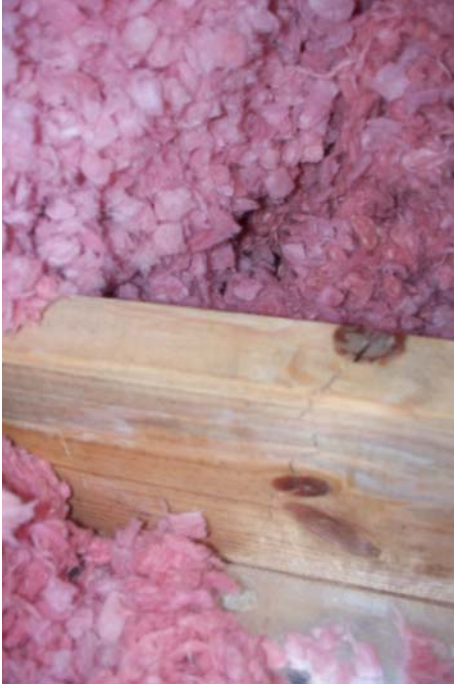
- **Module B: Truss #B6-8 – Partial Bottom Chord Fracture – Partial Vertical Break;**
WJE has reviewed and will be developing a fix

It was noted in the field that for the most part, a break of this type has not been documented in the past in this area of the building.

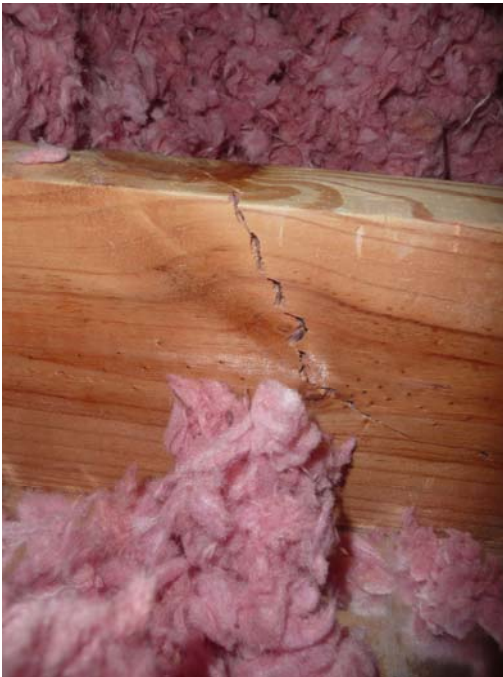
- **Module C: Truss #3 – Full Bottom Chord Fracture – Complete Vertical Break;**
Directly at the center of Building
WJE has reviewed and will be developing a fix

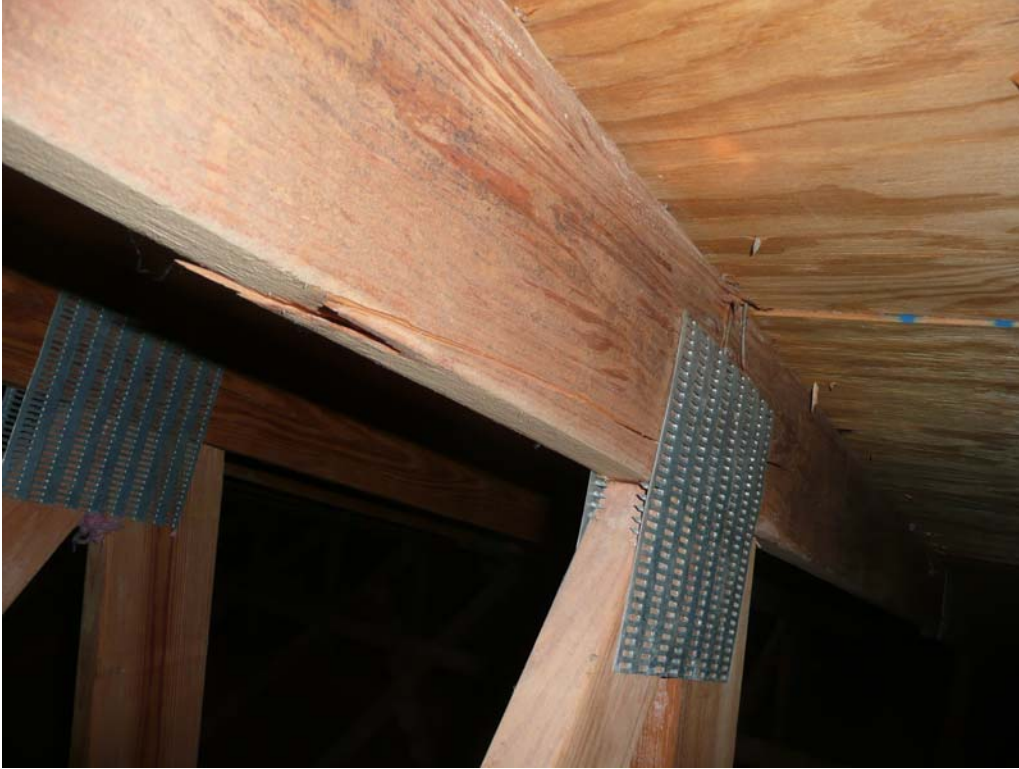
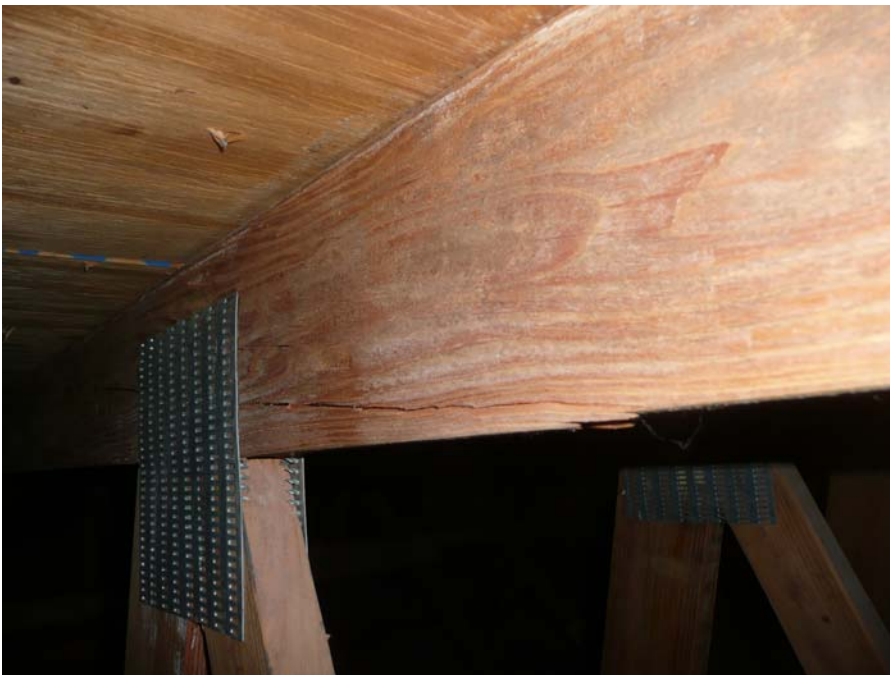
- **Module C: Truss #30 – Partial Top Chord Fracture; North side of Catwalk**
WJE has reviewed and will be developing a fix

It was noted in the field that a break of this type has not been documented in the past and has not been the typical type of break seen in other observations of the trusses.

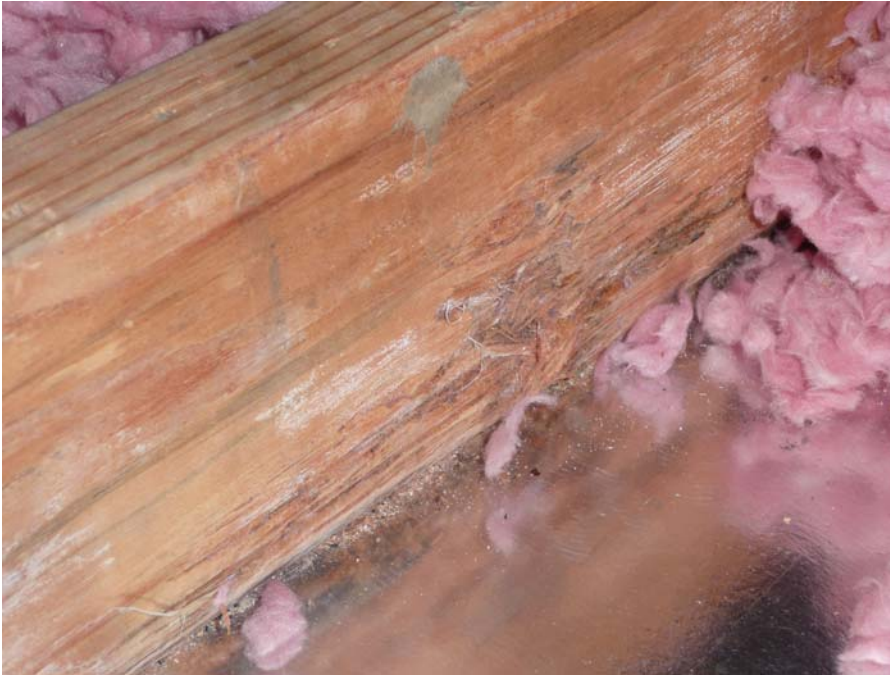
- **Module A: Trusses #8 – Construction Scar at the time of original construction**
Reviewed by Ralph Schmidt and WJE and determined to Not be Worthy of Attention

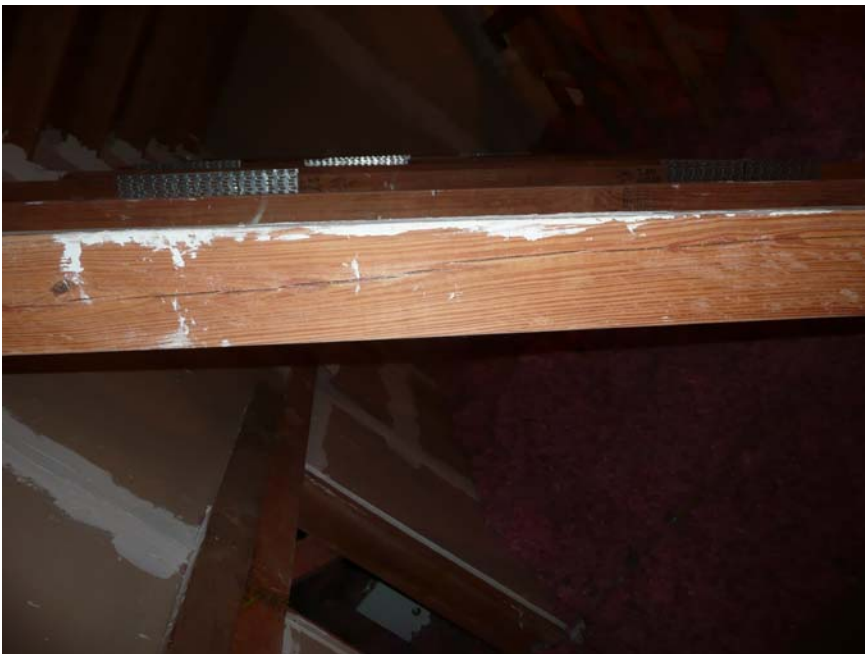
- **Module A: Trusses #20 – Longitudinal Check on Diagonal**
Reviewed by Ralph Schmidt and WJE and determined to Not be Worthy of Attention

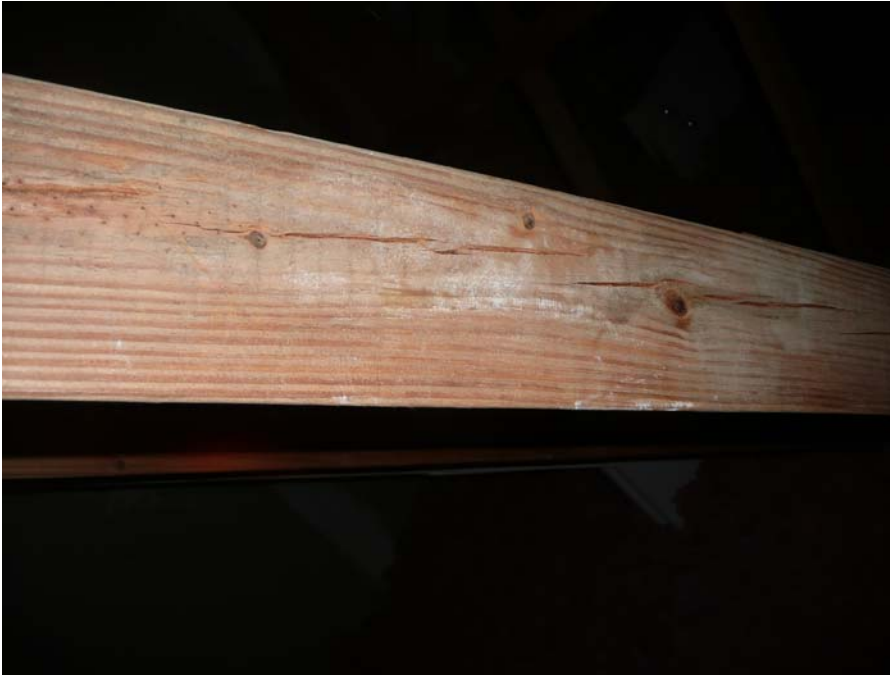
- **Module A: Trusses #78 – Longitudinal Checks on Diagonal**
Reviewed by Ralph Schmidt and WJE and determined to Not be Worthy of Attention

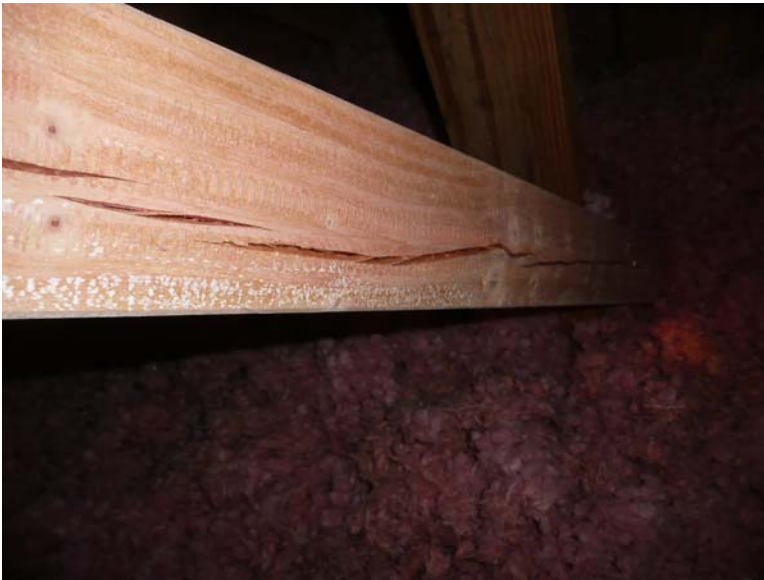
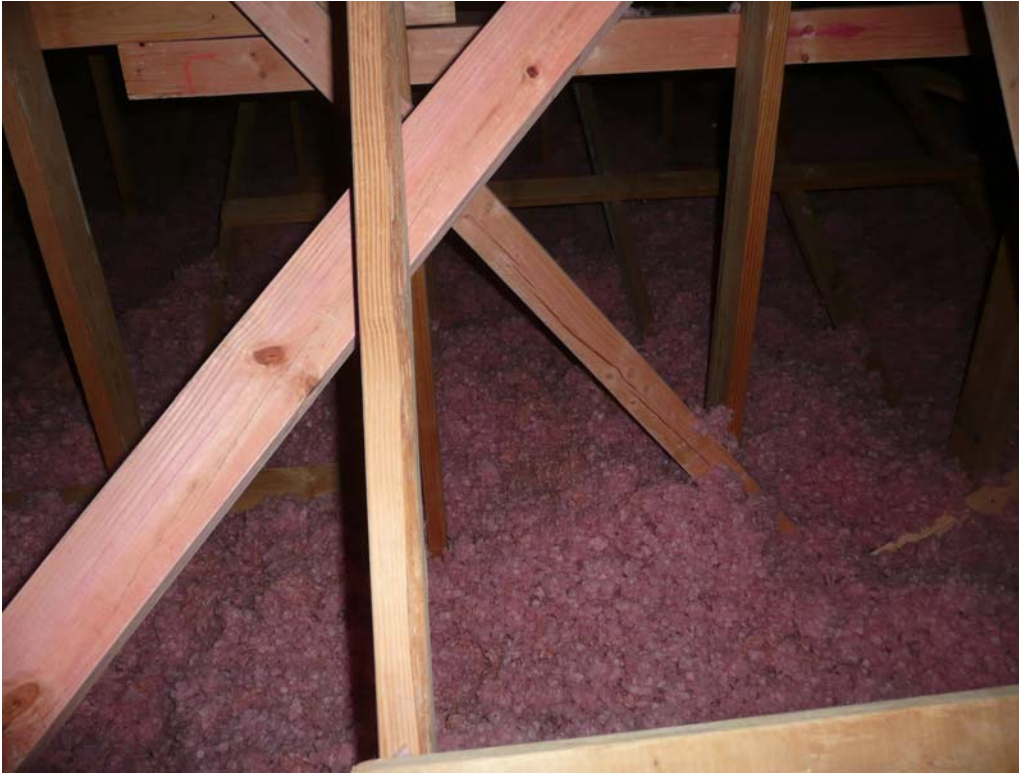
- **Module C: Trusses #86 - #88 – Season Check on Diagonal Member between Trusses**
Reviewed by Ralph Schmidt and WJE. Determined replacement of the diagonals would be the simplest correction instead of mending the existing material.

It was noted in the field that material used for the diagonal bracing was installed at original fix of building.

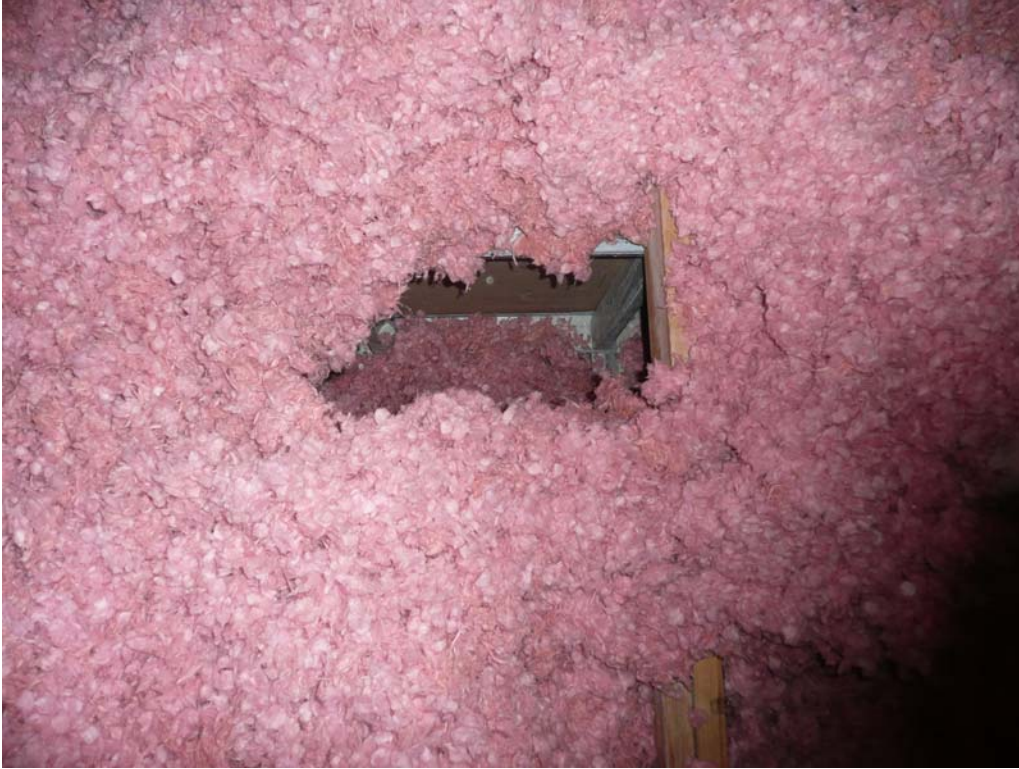
- ***Module A: Trusses #75 - #76– Foot Hole Damage; 6' North of Catwalk***
There has been damage caused by a foot slipping off a truss and going through the drywall and insulation. Drywall must be re-established, insulation cleaned up from on top of ceiling tiles and re-distributed in the attic space.

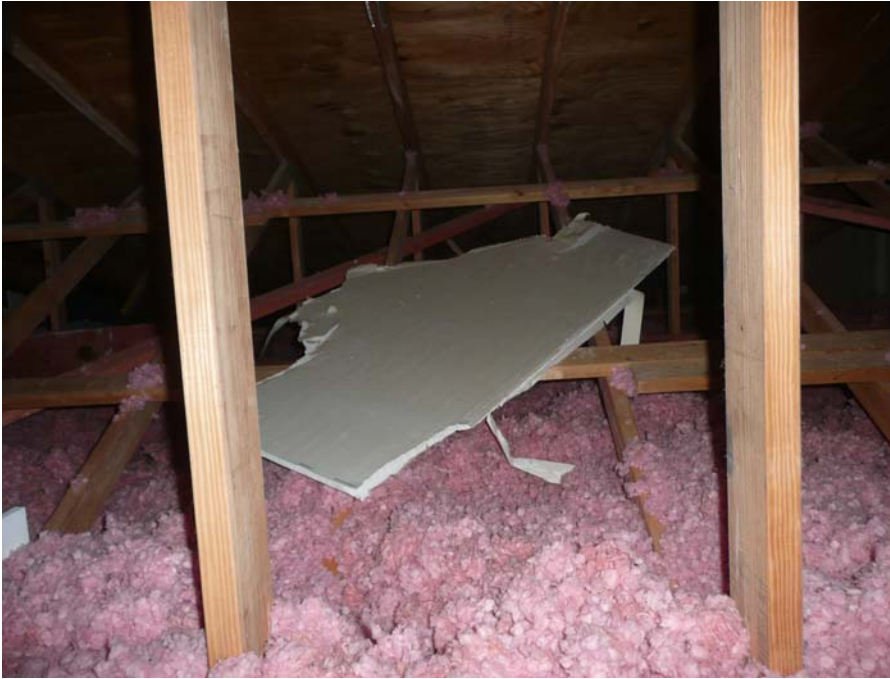
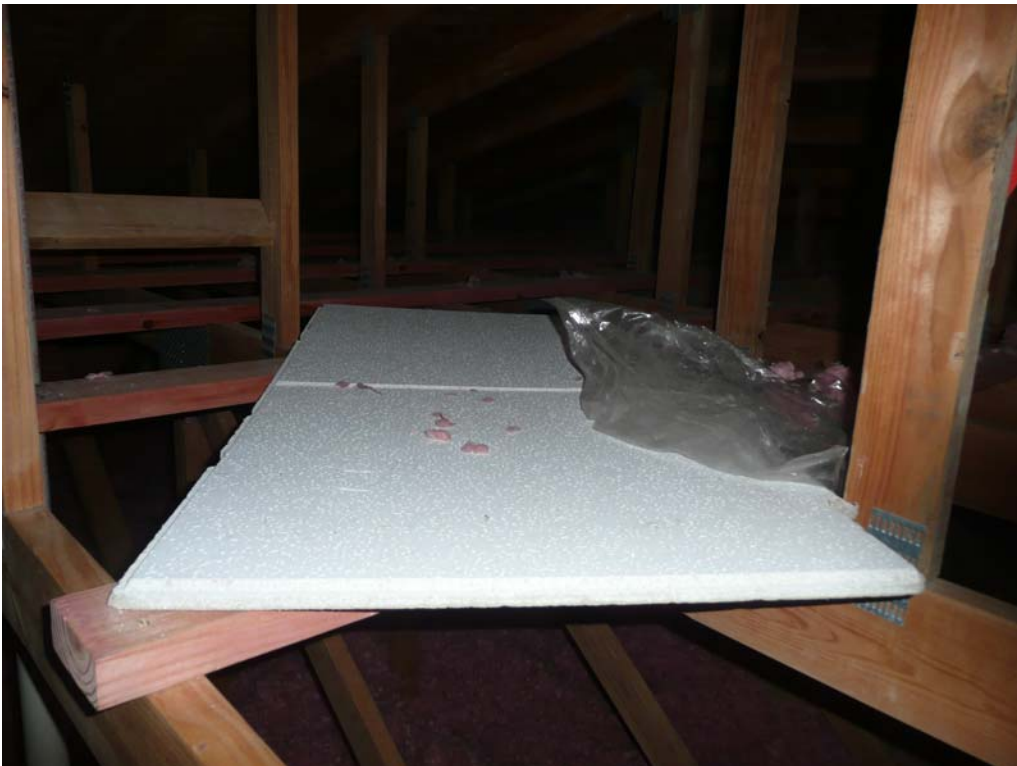
- **Module C: Drywall Debris and Ceiling Tile Debris**
There are sections of drywall and ceiling tile debris that have been left in the attic space from earlier repair jobs. Extra material needs to be removed from the attic space.
