# Gavin Central School

Ingleside, Illinois

## 2006 GAVIN INSPECTION

# 2007 GAVIN INSPECTION

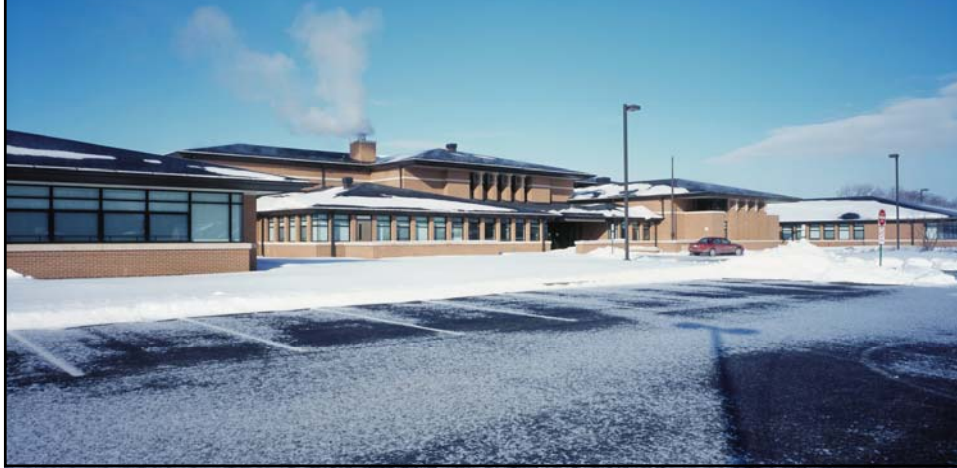
- Trusses inspected 6 months after completion of repairs. No additional repairs required.

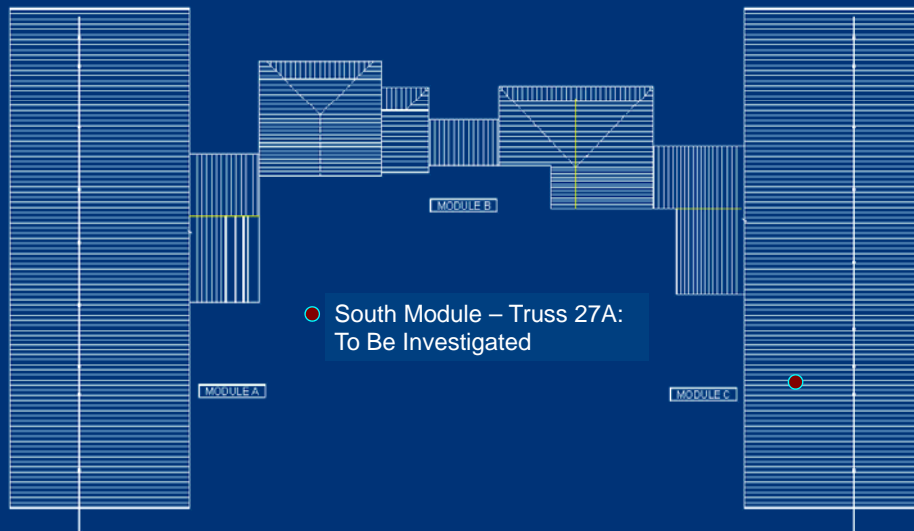
# 2008 GAVIN INSPECTION

- No repairs required following 2006 inspection.
- Conditions observed in 2007 and 2008 inspections are similar to previous conditions, but very limited relative to previous surveys.
- 3 of 4 repairs installed in 2007 - 2008 were preventative and non-structural.
- WJE 2007-2008 repairs are similar to previously installed WJE repairs.
