Gavin Central Elementary School

Observations related to Annual Roof Truss Inspection by Legat Architects

Date: March 27, 2012

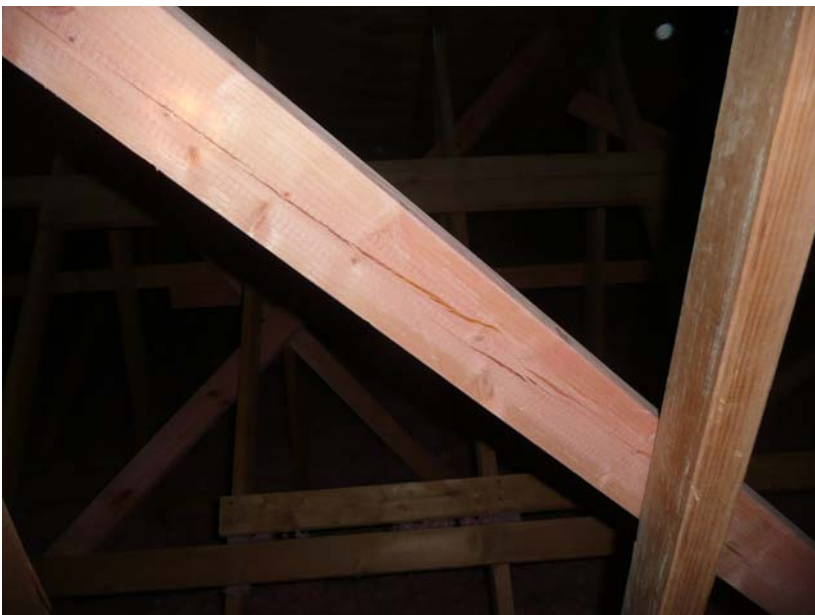
- **Module C: Trusses #86 - #88 – Season Check on Diagonal Member between Trusses**
Reviewed by Ralph Schmidt and WJE. Determined replacement of the diagonals would be the simplest correction instead of mending the existing material.

It was noted in the field that material used for the diagonal bracing was installed at original fix of building.
